PRODUCT NOTICE: BWA012N and BWA030N

November 21, 2018

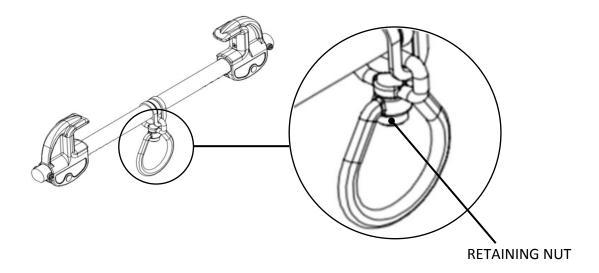
In ClimbTech BWA012N and BWA030N anchorage connectors manufactured before 2016, it has been found that, in rope access work where it is common for the D-ring to be rotated under body weight, the retaining nut may become loose over time. This possibility is accelerated when the swivel d-ring is not kept clean.

It is recommended that examination of this component be added to before use, and periodic inspections of any affected product still in service. Depending on frequency of use, it may be necessary to carry out periodic inspections more often. It is also recommended that a straight permanent mark be made across the swaged region and the exposed flat face of the retaining nut to determine its current alignment.

For all affected units still in service, the following steps shall be added to the inspection process:

- 1) Ensure that the exposed flat face of the retaining nut does not extend past the swaged region.
- 2) Inspect alignment mark to ensure retaining nut has not moved.
- 3) Ensure retaining nut is secured to the swaged region and does not rotate or wiggle.

If any of the above inspection criteria are not met, the anchorage connector should be removed from service immediately.
